**EVENT INVOLVING RYANAIR FLIGHT FR4978  
IN BELARUS AIRSPACE ON 23 MAY 2021**

Report of the ICAO Fact-Finding Investigation

January 2022

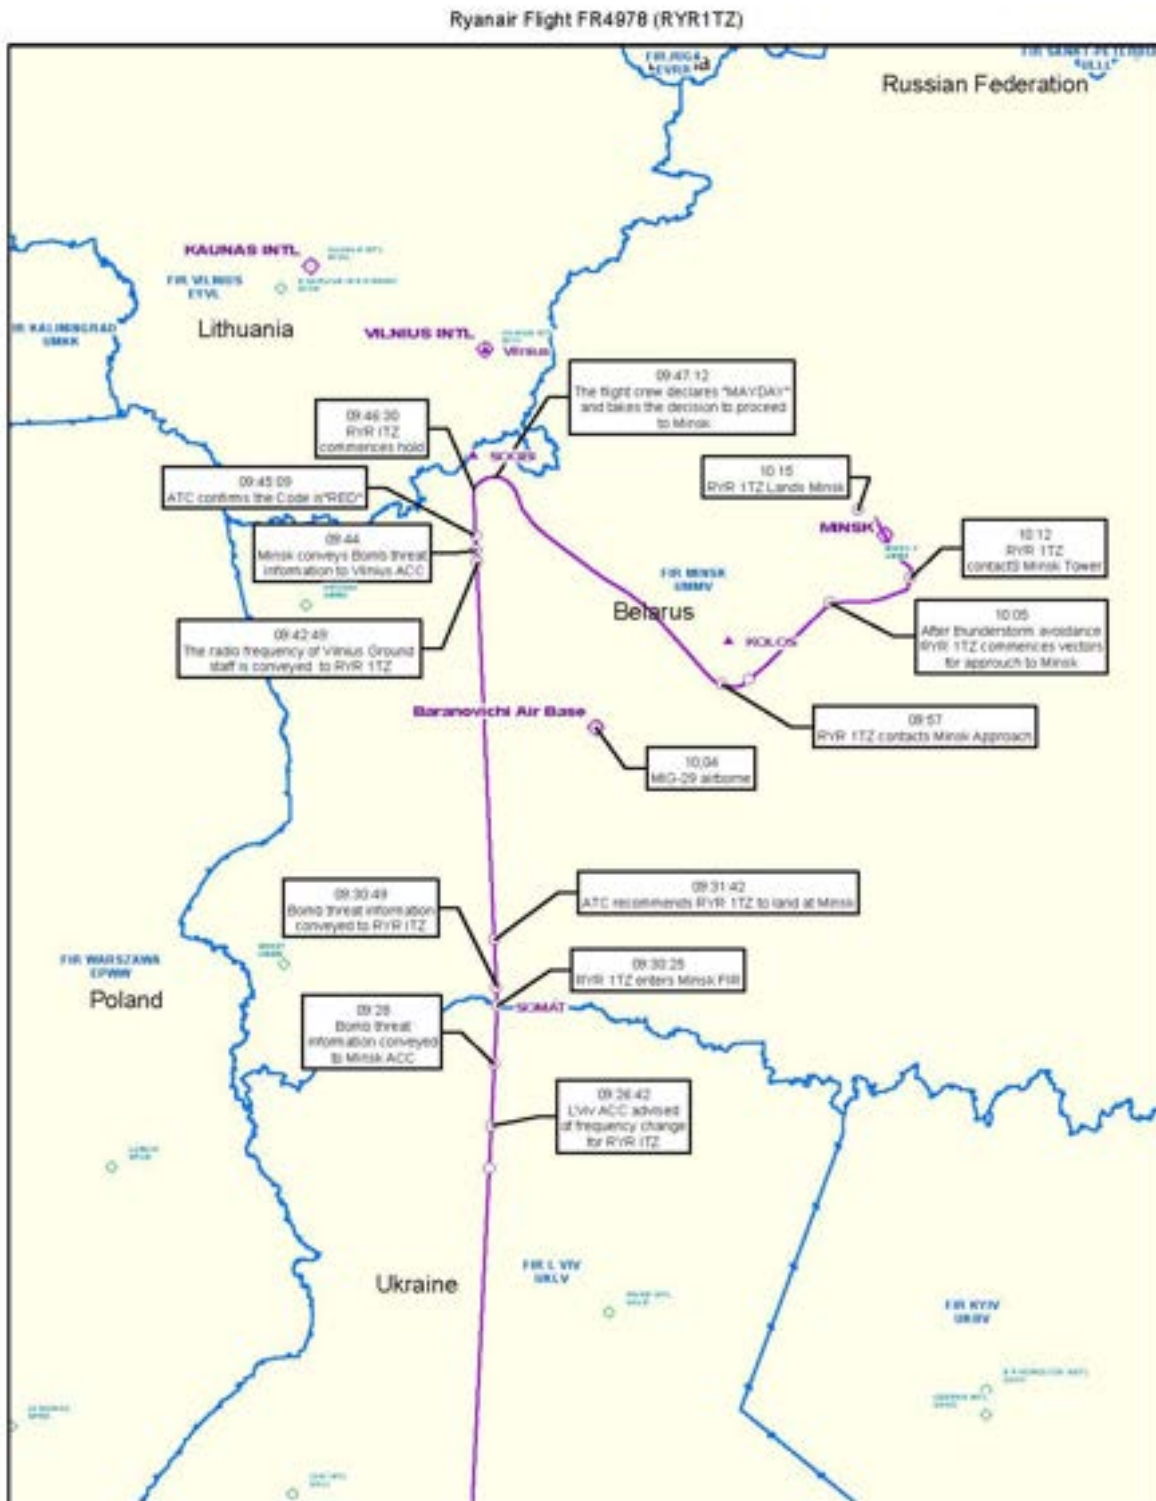
#### MAPPING OF ACTUAL RYANAIR FLIGHT 4978 FLIGHT PATH ON 23 MAY 2021

3.10.1. Meteorological conditions did not play a role in the diversion of RYR 1TZ to Minsk Airport. However, the presence of thunderstorms and cumulonimbus clouds explain the indirect route flown by RYR 1TZ to Minsk Airport and the provision of weather avoidance radar vectors following the initiation of the diversion.
